NO. 145

TECHNICAL SERVICE BULLETIN

January 31, 1963

Re: BJ7 HEALEY CONVERTIBLE TOPS

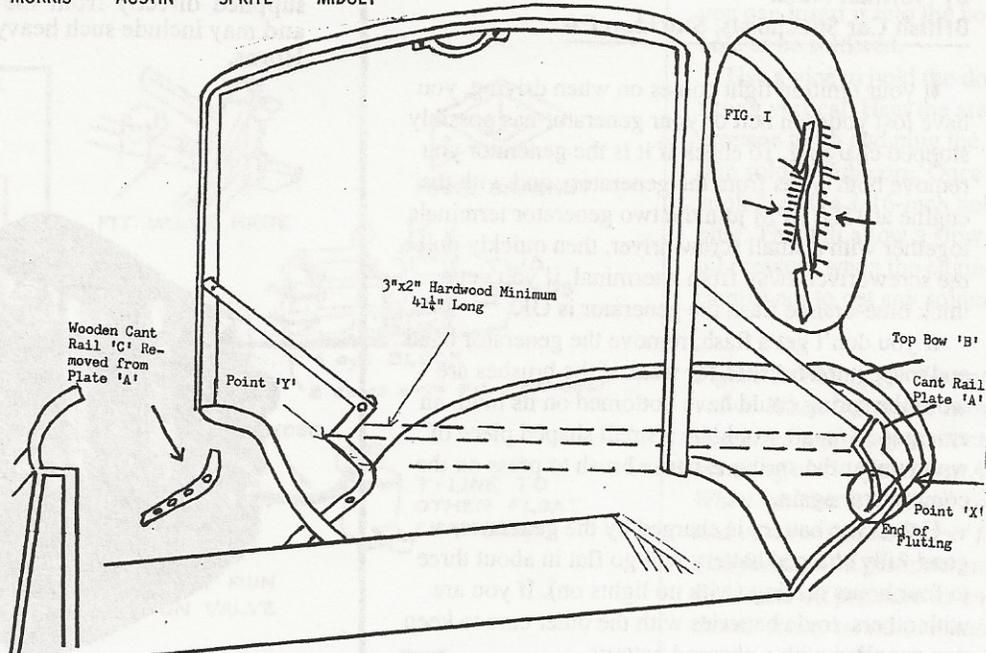
Damage to the top material on the Austin Healey 3000 MK II (BJ7) Convertible can occur at the two following points:-

1. With the top up, the sharp point of the clamp securing the convertible top to the windshield may cut into the top immediately behind the windshield rail.
2. With the top down, the sharp edge of the rear cockpit moulding lip may cut the folds of the top where it becomes trapped between the moulding and the frame.

(c) Increased clearance between the rear cockpit moulding and the top may be gained by resetting the position of the cant rail plate 'A' and the front top bow 'B'. Proceed as follows:-

- I. Remove wooden cant rail 'C' from each side of car. See Sketch Fig. II
- II. Using a suitable clamp and packing, partially straighten the bend at each end of the top bow 'B' as shown in Diagram I.
- III. A piece of 3" x 2" should be cut to a length of $4\frac{1}{4}$ " and inserted between the cant rail plates 'A' in order to maintain $4\frac{1}{4}$ " between points 'Y'.
- IV. Using a body jack or sash cramp located at points 'X' (end of fluting on bow) on both ends of main top bow 'B', pull in on bow in order to give a maximum clearance of $5/16$ " between the convertible top and the cockpit moulding lip.
- V. It must be emphasized that the top bow 'B' and the head should be centralized before measuring the $5/16$ " clearance at the moulding lip.
- VI. Refit wooden cant rail 'C'
- VII. Erect hood to check operation
