Rebuilding the Lucas HF1748 Horn

Written by: Domenic DeZan, January 26, 2021

LUCAS WORKSHOP INSTRUCTIONS

MODELS HF1746-47-48

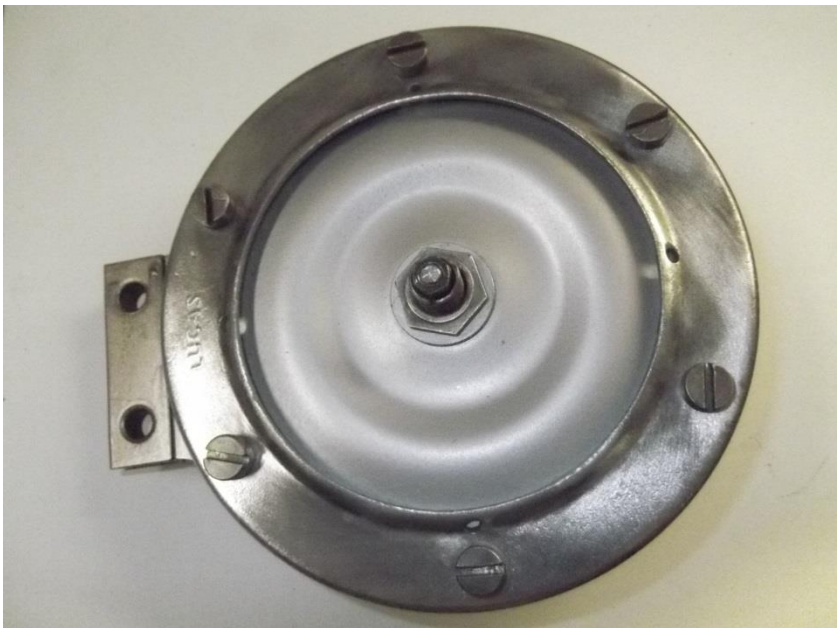
Now remove the diaphragm assembly complete with the armature. There is a paper gasket on either side of the diaphragm. Save one if possible to use as a template when making a new gasket.

If the assembly is corroded on the above mentioned parts, then soak those areas on both sides of the diaphragm for several days and use a heat gun prior to removal. If the cone nut is rusted tight, the guide rod will break when you try to remove it. These parts are not available.

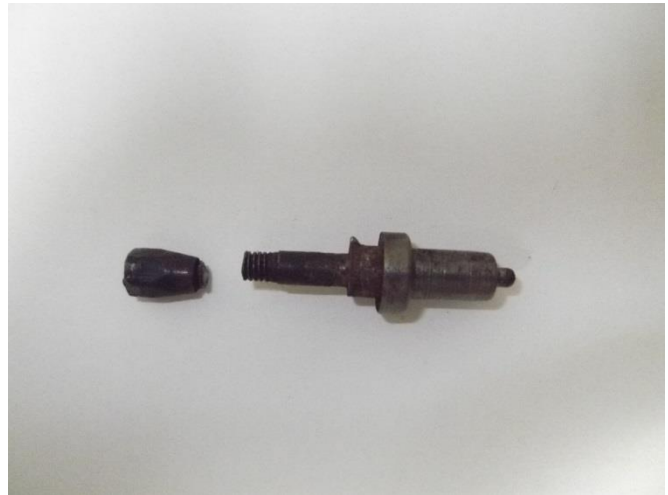
If the guide rod does break then it can be repaired with the use of a drill press or lathe.

Cut off the shank portion and drill a .159 inch diameter concentric hole approximately 5/16 deep and cut 10-32 UNF threads with a tap. It is important to ensure the hole is concentric and in-line with the guide rod axis.

Install a new threaded portion using a long 10-32 screw and make it about .10 inch longer to fully engage the cone nut. Use a bit of Loctite on the threads before fully bottoming the threaded portion in the new hole.

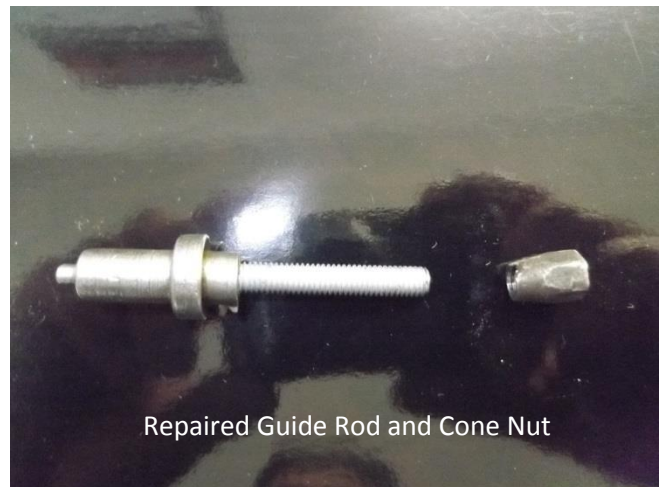
The broken threaded portion of the guide rod still in the cone nut can be drilled out and removed with an easy out. Tap with a 10-32 UNF thread. The guide rod is just mild steel so drilling and tapping is easy.

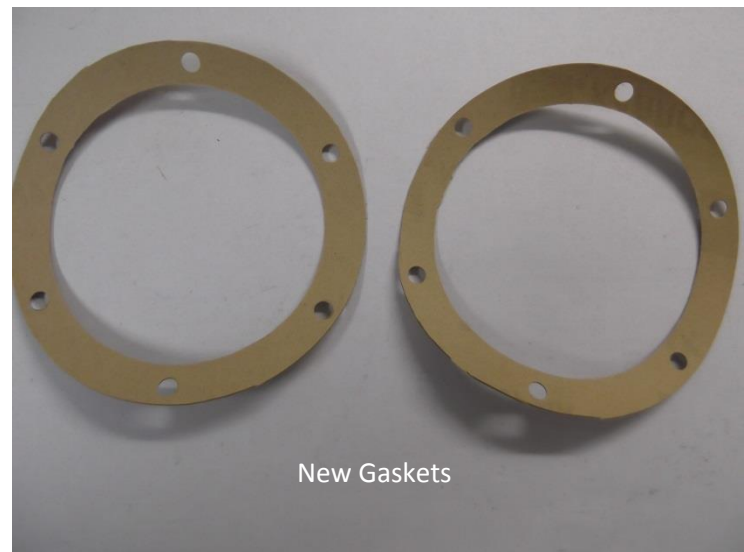
One of the original gaskets can be used as a pattern or make a pattern using the horn body itself.

Cut the new gaskets using FEL-PRO KARROPAK 1/32 inch thick gasket paper. For those inclined to want to fine tune the horn frequency, Terrence Jones sells these gaskets in a set of various thicknesses which will slightly alter the horn sound.

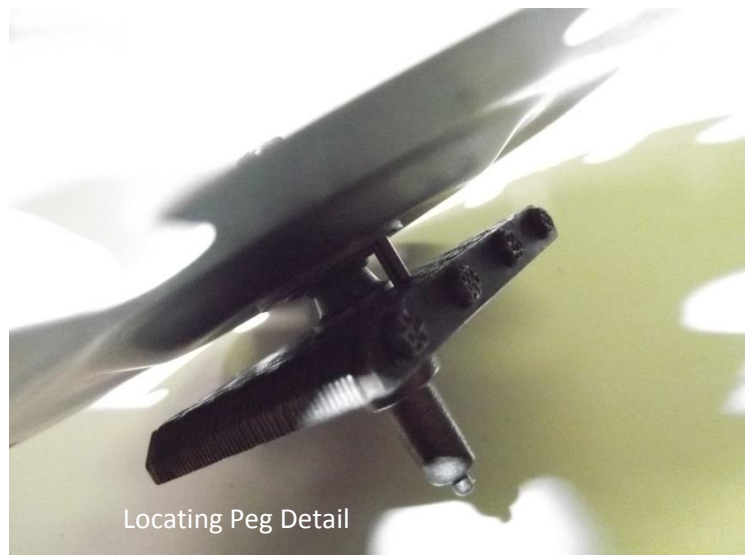
Locating Peg Detail

Insure that the locating peg is inserted properly into the armature hole.

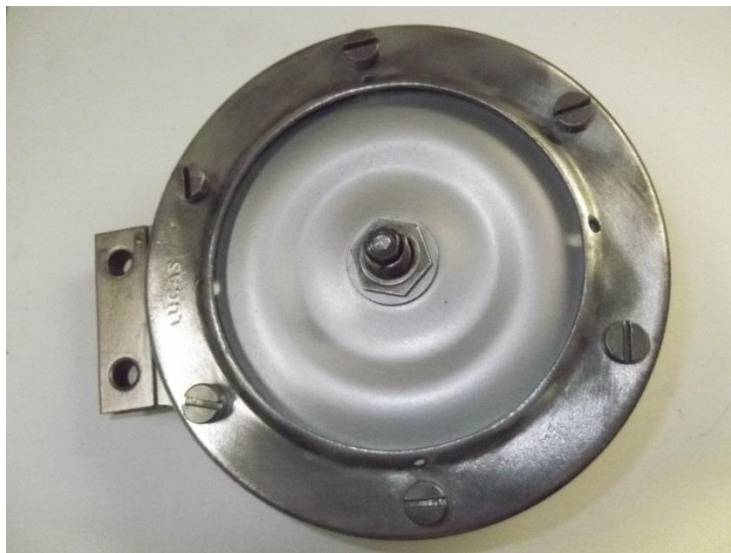
It should look like the figure to the right.

Install the two gaskets, rim, and the mounting bracket with I.D. plate. Secure with the six cheese head screws/nuts/washers. Do not over-tighten the screws. It is recommended to allow the assembly to sit overnight and then tighten the screws a bit more to make up for the gasket compression.

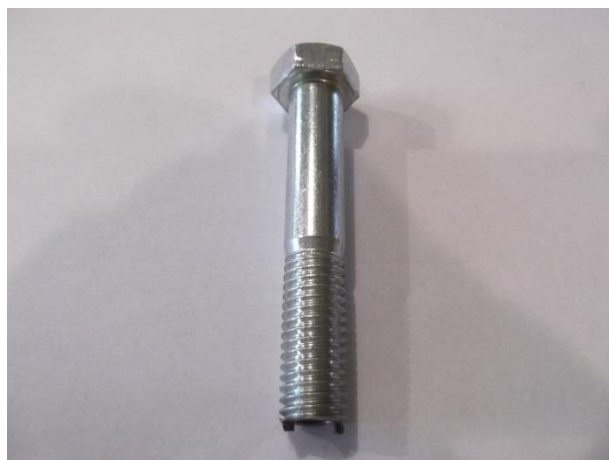
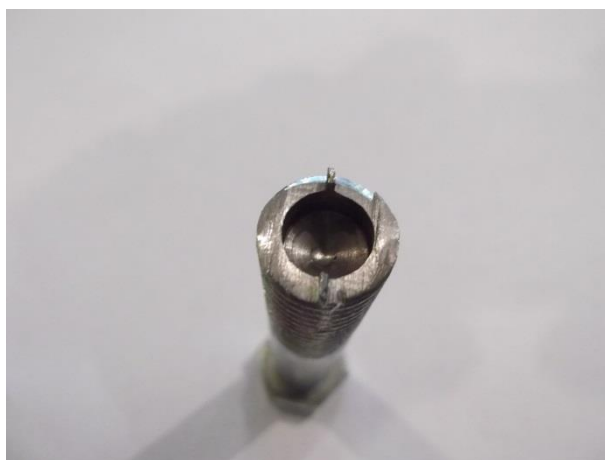
You can make it from a 1/2 inch diameter bolt using a drill press, bench grinder and file. The idea is to make two protruding tabs that will fit into the slots on the end of the Adjusting Sleeve with a bore that allows the cone nut to enter.

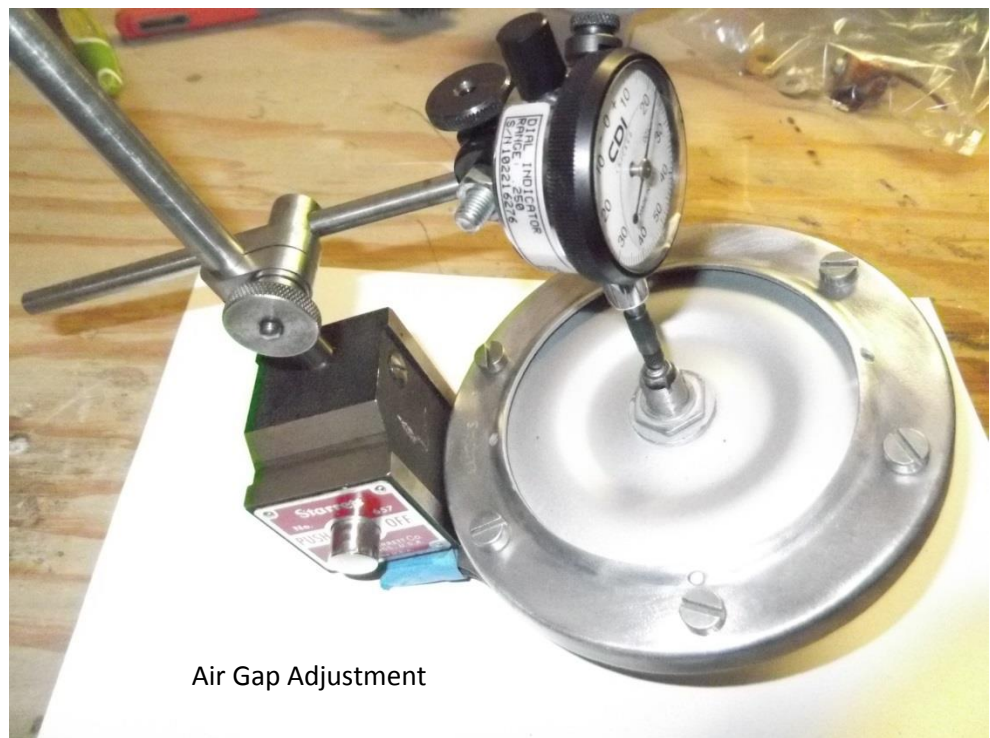
Air Gap Adjustment

Now perform operation 4b, setting the armature to core face air gap. Note the different air gap values shown in the instructions for the low note and high note horns. It is necessary to use a dial indicator and magnetic base to accomplish this task. These can be sourced from Harbor Freight for about \$30. The magnetic base is installed onto the horn mounting bracket. Note that the adjustment screw on the back of the horn must be turned several turns clockwise to ensure that the contacts remain closed during this operation. Apply power to the horn and verify the movement of the indicator. Use the tool to rotate the adjusting sleeve to obtain the correct value. Lightly tighten the adjusting sleeve lock nut and the cone nut while energized.

After the air gap has been set, repeat operation 4a with the cone nut slightly loose. Then tighten the cone nut while energized. Tighten the adjusting sleeve lock nut fully and then repeat operation 4b to verify the air gap is still correct. Repeat 4b completely if the air gap has changed.

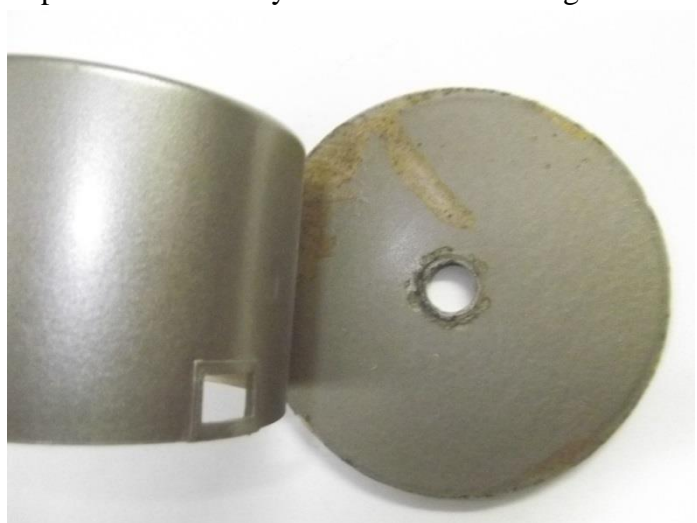
The closest color I could find is Duplicolor Ford Arizona Beige. You can see the comparison in the figure with the original paint on the backside of the Tone Disc.

The electrical connection on the back of the horn was masked off. The entire horn was primed with Duplicolor lacquer primer and then painted with several color coats. Two coats of Duplicolor clear lacquer was then applied for additional protection.
