# Rebuilding the Lucas HF1748 Horn

Written by: Domenic DeZan, January 26, 2021

### LUCAS WORKSHOP INSTRUCTIONS

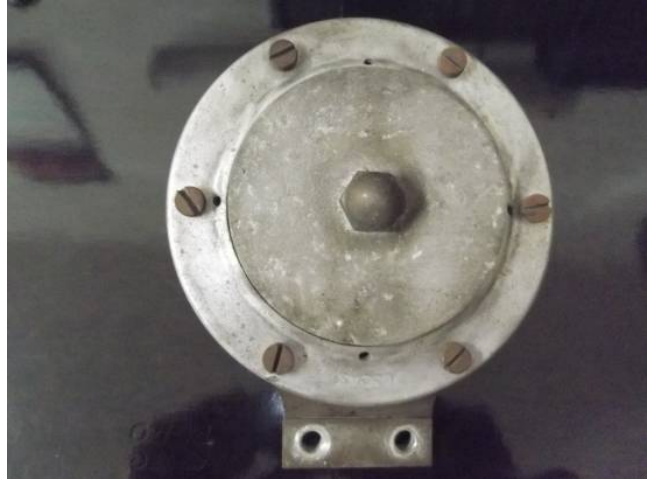
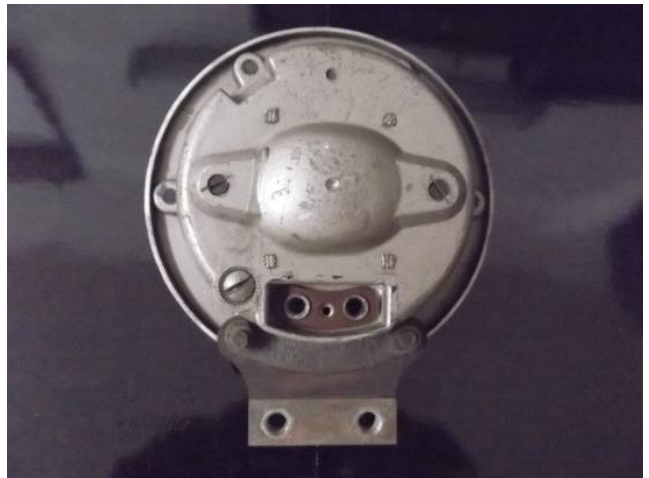
After removal from the vehicle, inspect the horn for rust and corrosion. If the rim is corroded and/or fractured, these can be purchased as a new reproduction from a seller on eBay.

There are two areas of concern that can lead to disappointment with the project. The first is the six cheese head screws that retain the rim. These are ¼-26 BSF screws which have a slightly different thread shape and size as compared to standard ¼-28 UNF threads. If these look like they may be rusted to the aluminum housing, then several days of soaking with penetrating fluid combined with a heat gun may get them loose. These screws are available from [Britishfasteners.com](http://Britishfasteners.com) or GWR Fasteners in the UK. The threads, if damaged, can be repaired with a Heli-coil of the proper BSF thread.

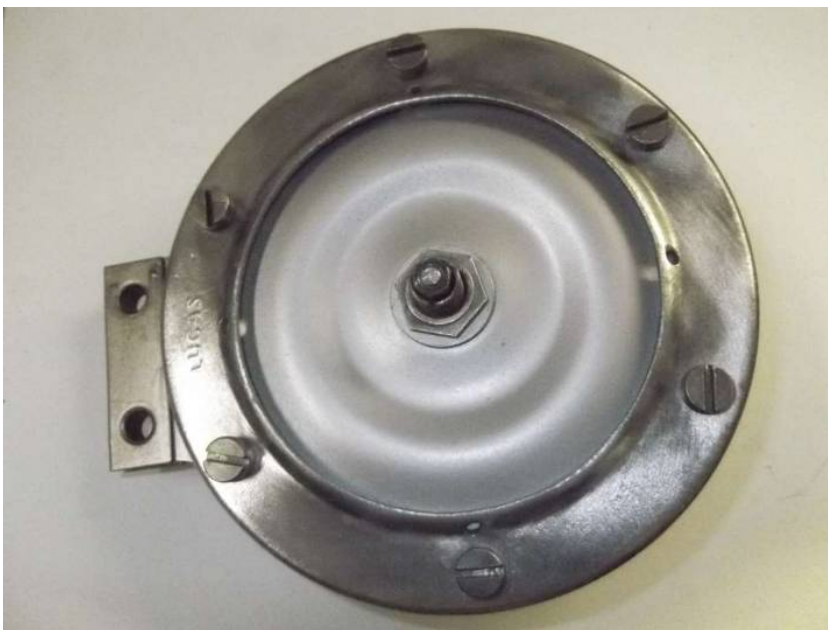
Now remove the diaphragm assembly complete with the armature. There is a paper gasket on either side of the diaphragm. Save one if possible to use as a template when making a new gasket.

If the assembly is corroded on the above mentioned parts, then soak those areas on both sides of the diaphragm for several days and use a heat gun prior to removal. If the cone nut is rusted tight, the guide rod will break when you try to remove it. These parts are not available.

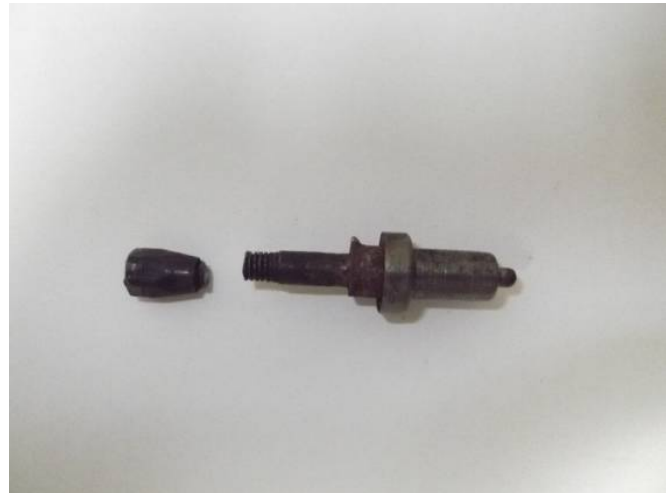
Cut off the shank portion of the guide rod and drill a 0.159 inch (4.0 mm if using 2BA) diameter concentric hole approximately 5/16 deep and cut 10-32 UNF threads (or 2BA) with a tap. It is important to ensure the hole is concentric and in-line with the guide rod axis.

Install the new threaded portion using the screw and make it about 0.10 inch longer to fully engage the cone nut. Use a bit of Loctite on the threads before fully bottoming the threaded portion in the new hole.

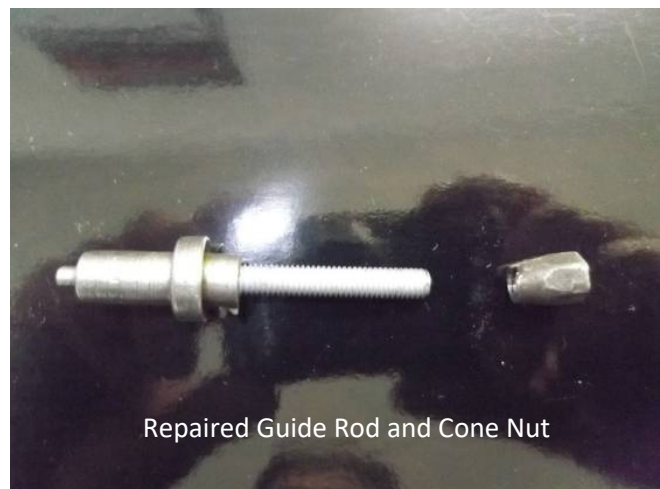
The broken threaded portion of the guide rod still in the cone nut can be drilled out and removed with an easy out. Re-tap with a 2BA tap or with a 10-32 UNF thread. The guide rod is just mild steel so drilling and tapping is easy.

Proceed to disassemble the diaphragm assembly by placing it in a vise and gently clamping down on the sides of the armature. Slightly loosen the sleeve locknut with a wrench and then unscrew the cone nut. At this point the diaphragm complete with the adjusting sleeve, locknut, and ball joint should come off as one assembly. Do not use excessive force and apply more penetrating fluid if necessary.

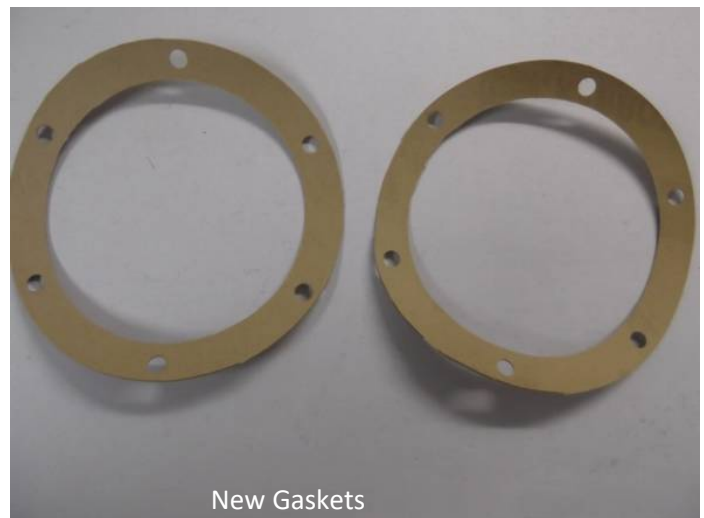
New Gaskets

One of the original gaskets can be used as a pattern or make a pattern using the horn body itself.

Cut the new gaskets using FEL-PRO KARROPAK 1/32 inch thick gasket paper or equivalent.

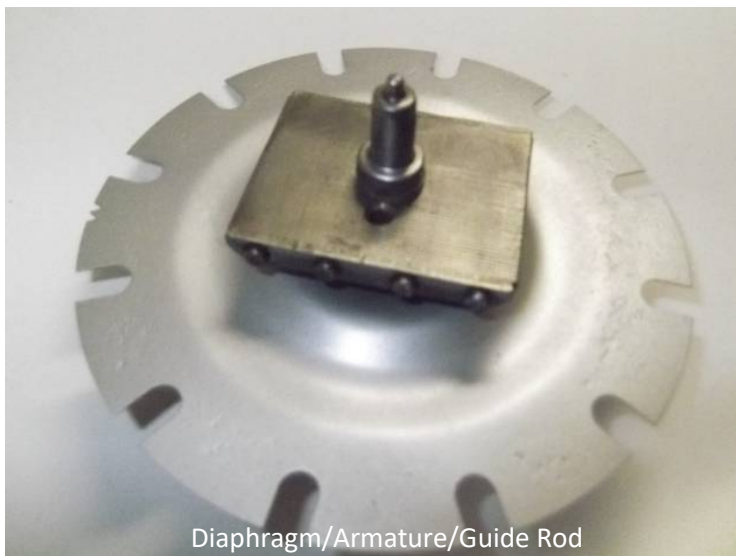
The brass swivel ring is beveled on one end and this end mates to the bevel on the guide rod.

Apply a light coat of grease on the operating surfaces of the ball joint, guide rod tip, and guide spring bearing in accordance with page 4 of the Lucas instructions.

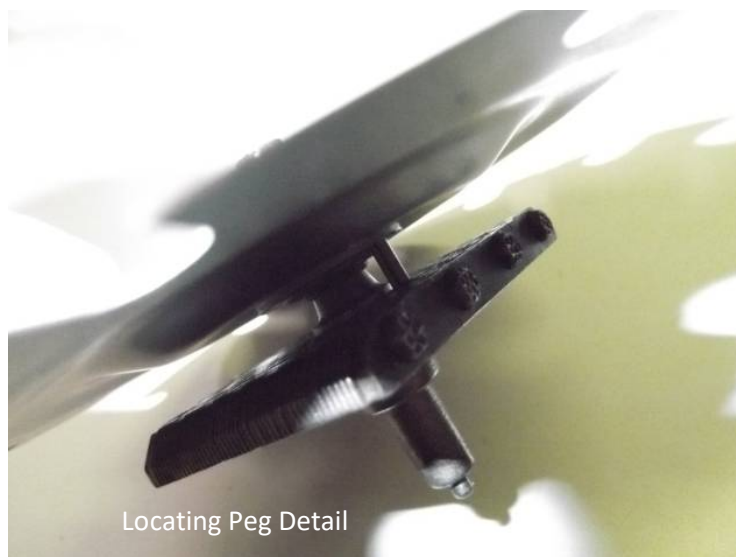
Start by threading the adjusting sleeve into the diaphragm until it is flush with the back face of the diaphragm. Install the adjusting sleeve lock nut until it bottoms on the diaphragm and tighten finger tight only.

Install the swivel ring on the guide rod with the bevel first. Then install the armature and the ball joint on the guide rod. Install the diaphragm and then the cone nut finger tight.

The diaphragm assembly is now complete.

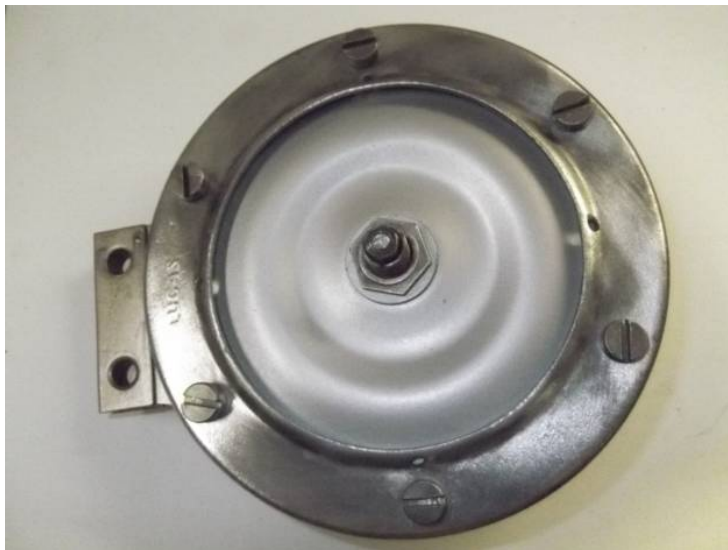
Install the two gaskets, rim, and the mounting bracket with I.D. plate. Secure with the six cheese head screws/nuts/washers. Do not over-tighten the screws. It is recommended to allow the assembly to sit overnight and then tighten the screws a bit more to make up for the gasket compression.

It should look like the figure to the right.

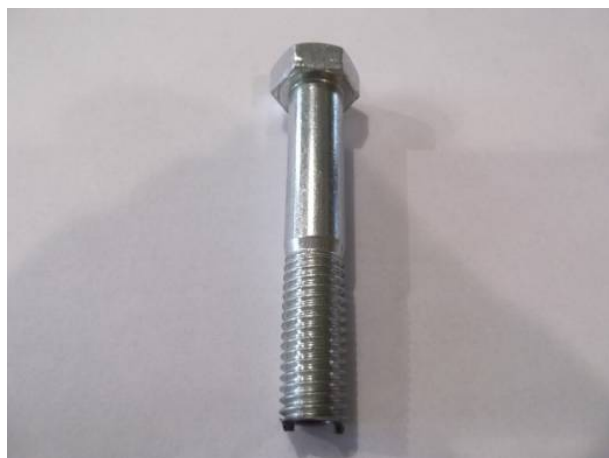
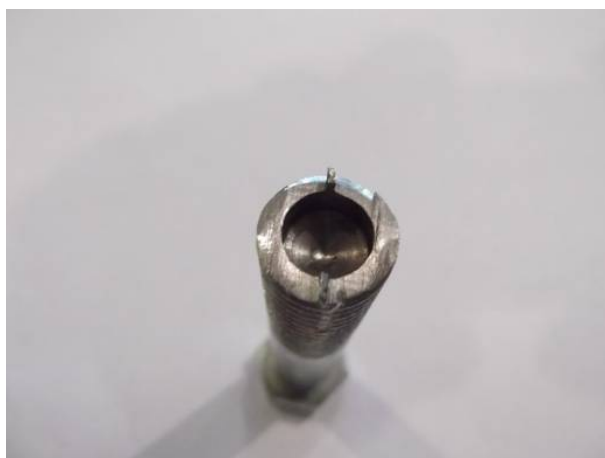
You can make it from a ½ inch diameter bolt using a drill press, bench grinder and file. The idea is to make two protruding tabs that will fit into the slots on the end of the Adjusting Sleeve with a bore that allows the cone nut to enter.

Read through the Lucas Workshop Instructions to get familiar about the process in Section 4a and 4b. It is necessary to make the special tool as shown in Figure 2 of the instructions. This will be used to rotate the Adjusting Sleeve to set the air gap of the Armature and coil core face.

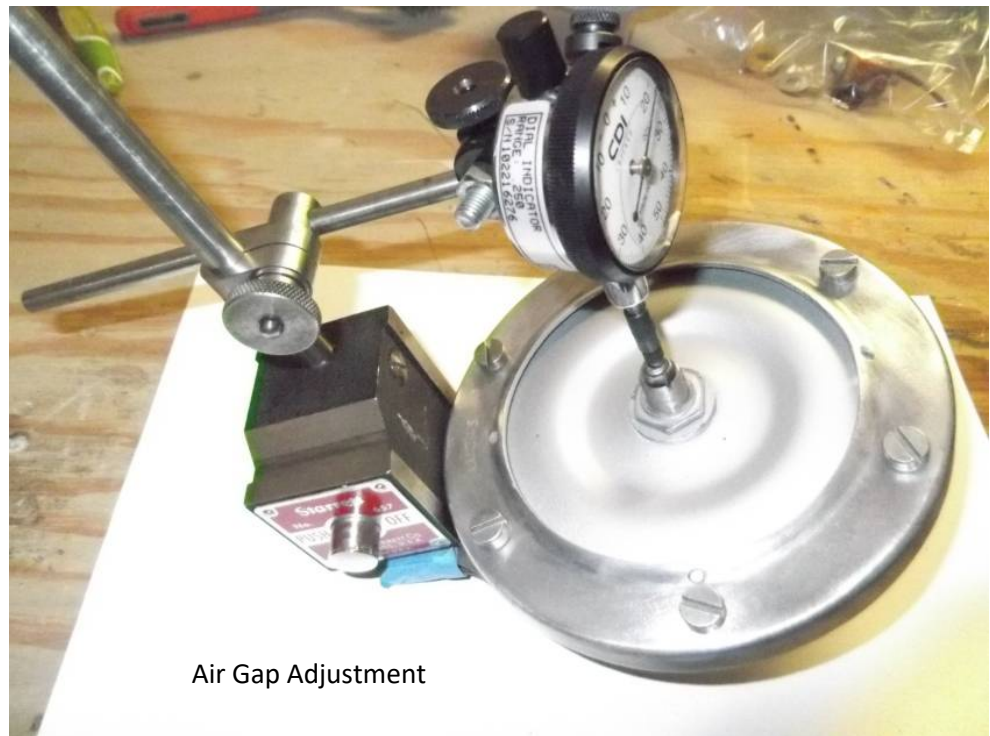
Air Gap Adjustment

Now perform operation 4b, setting the armature to core face air gap. Note the different air gap values shown in the instructions for the low note and high note horns. It is necessary to use a dial indicator and magnetic base to accomplish this task. These can be sourced from Harbor Freight for about \$30. The magnetic base is installed onto the horn mounting bracket. Note that the adjustment screw on the back of the horn must be turned several turns clockwise to ensure that the contacts remain closed during this operation. Apply power to the horn and verify the movement of the indicator. Use the tool to rotate the adjusting sleeve to obtain the correct value. Lightly tighten the adjusting sleeve lock nut and the cone nut while energized.

After the air gap has been set, repeat operation 4a with the cone nut slightly loose. Then tighten the cone nut while energized. Tighten the adjusting sleeve lock nut fully and then repeat operation 4b to verify the air gap is still correct. Repeat 4b completely if the air gap has changed.

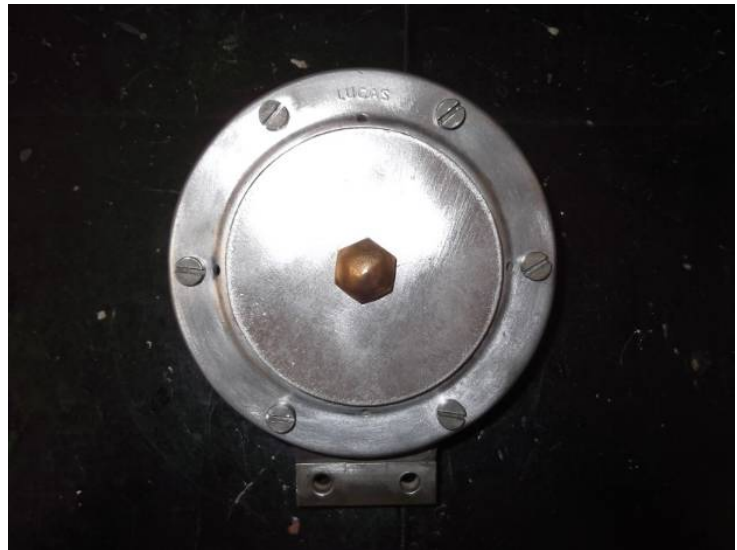
Turn the adjusting screw several turns counter-clockwise to undo the previous setting during the air gap setting procedure.

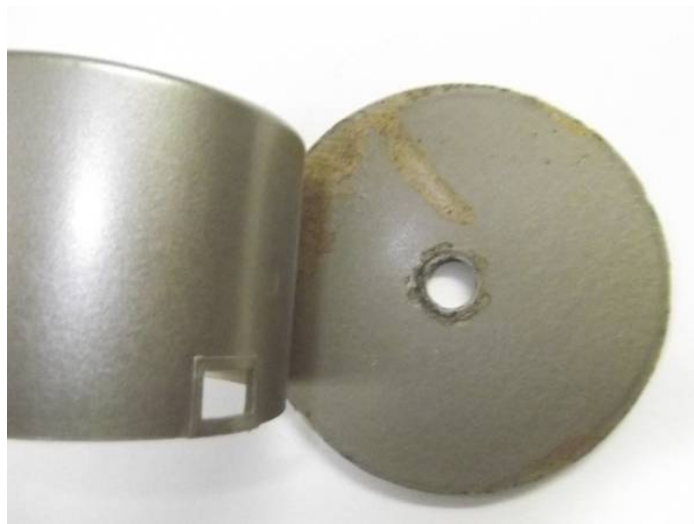
The closest color I could find is Duplicolor Ford Arizona Beige. You can see the comparison in the figure with the original paint on the backside of the Tone Disc.

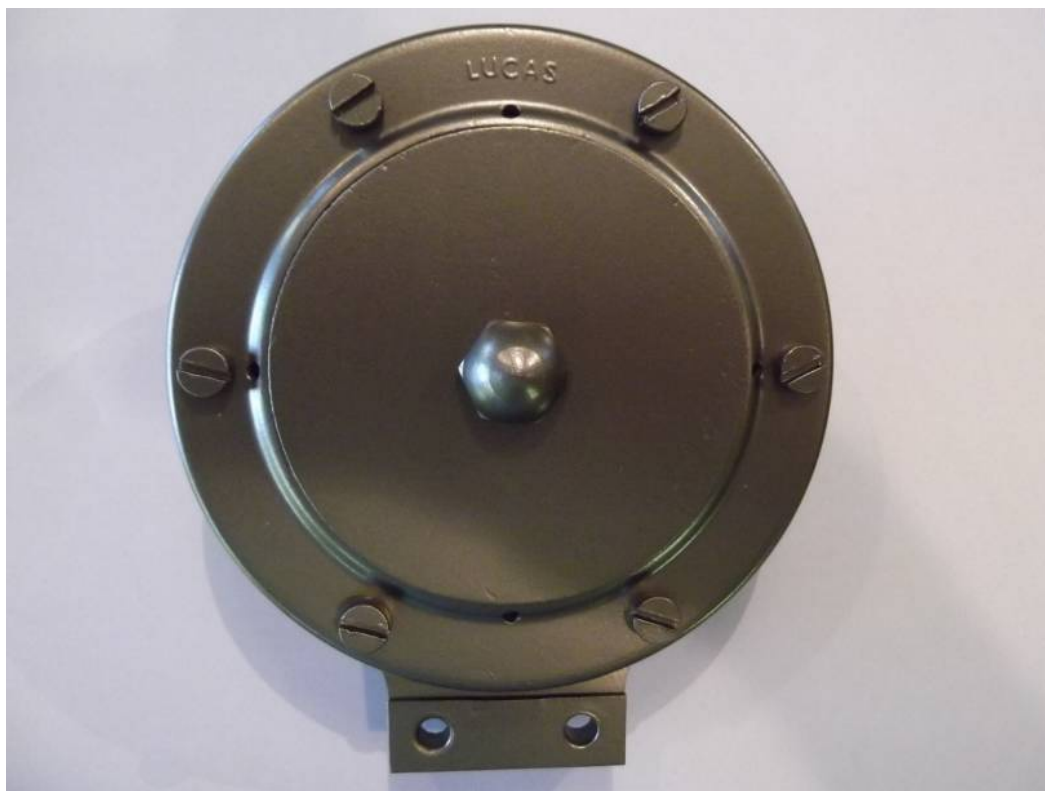
Here is a horn painted with Duplicolor Arizona Beige.

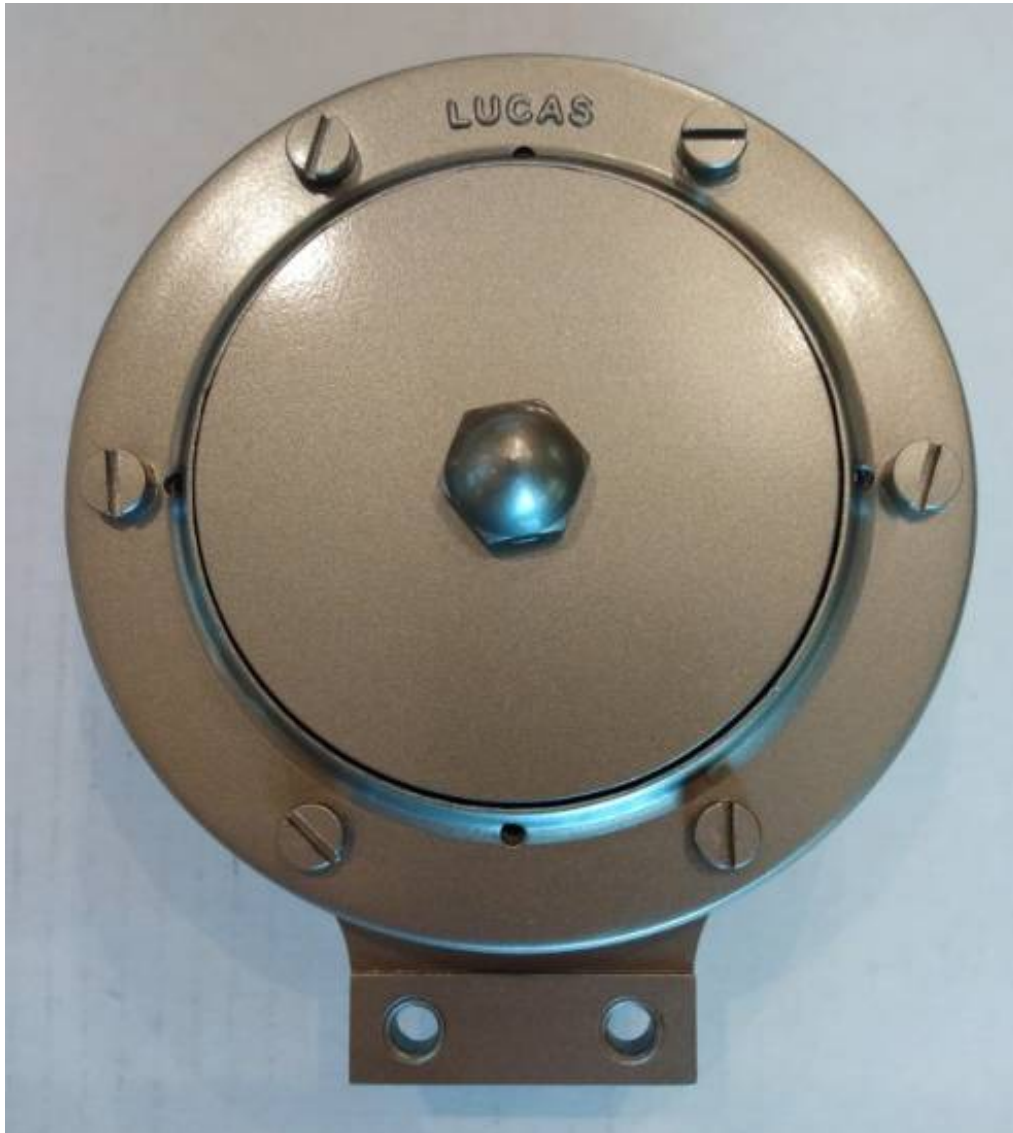
Here is a horn painted with the PPG color matched paint.
