Overhaul of TR2/3 Steering Control Head

This technicality article originally appeared in Issue 62, Summer 1985. Readers are advised that part numbers, reproduction parts and assemblies may have changed in the intervening years and should check their supplier's latest parts book.

Edited by Ian Cornish

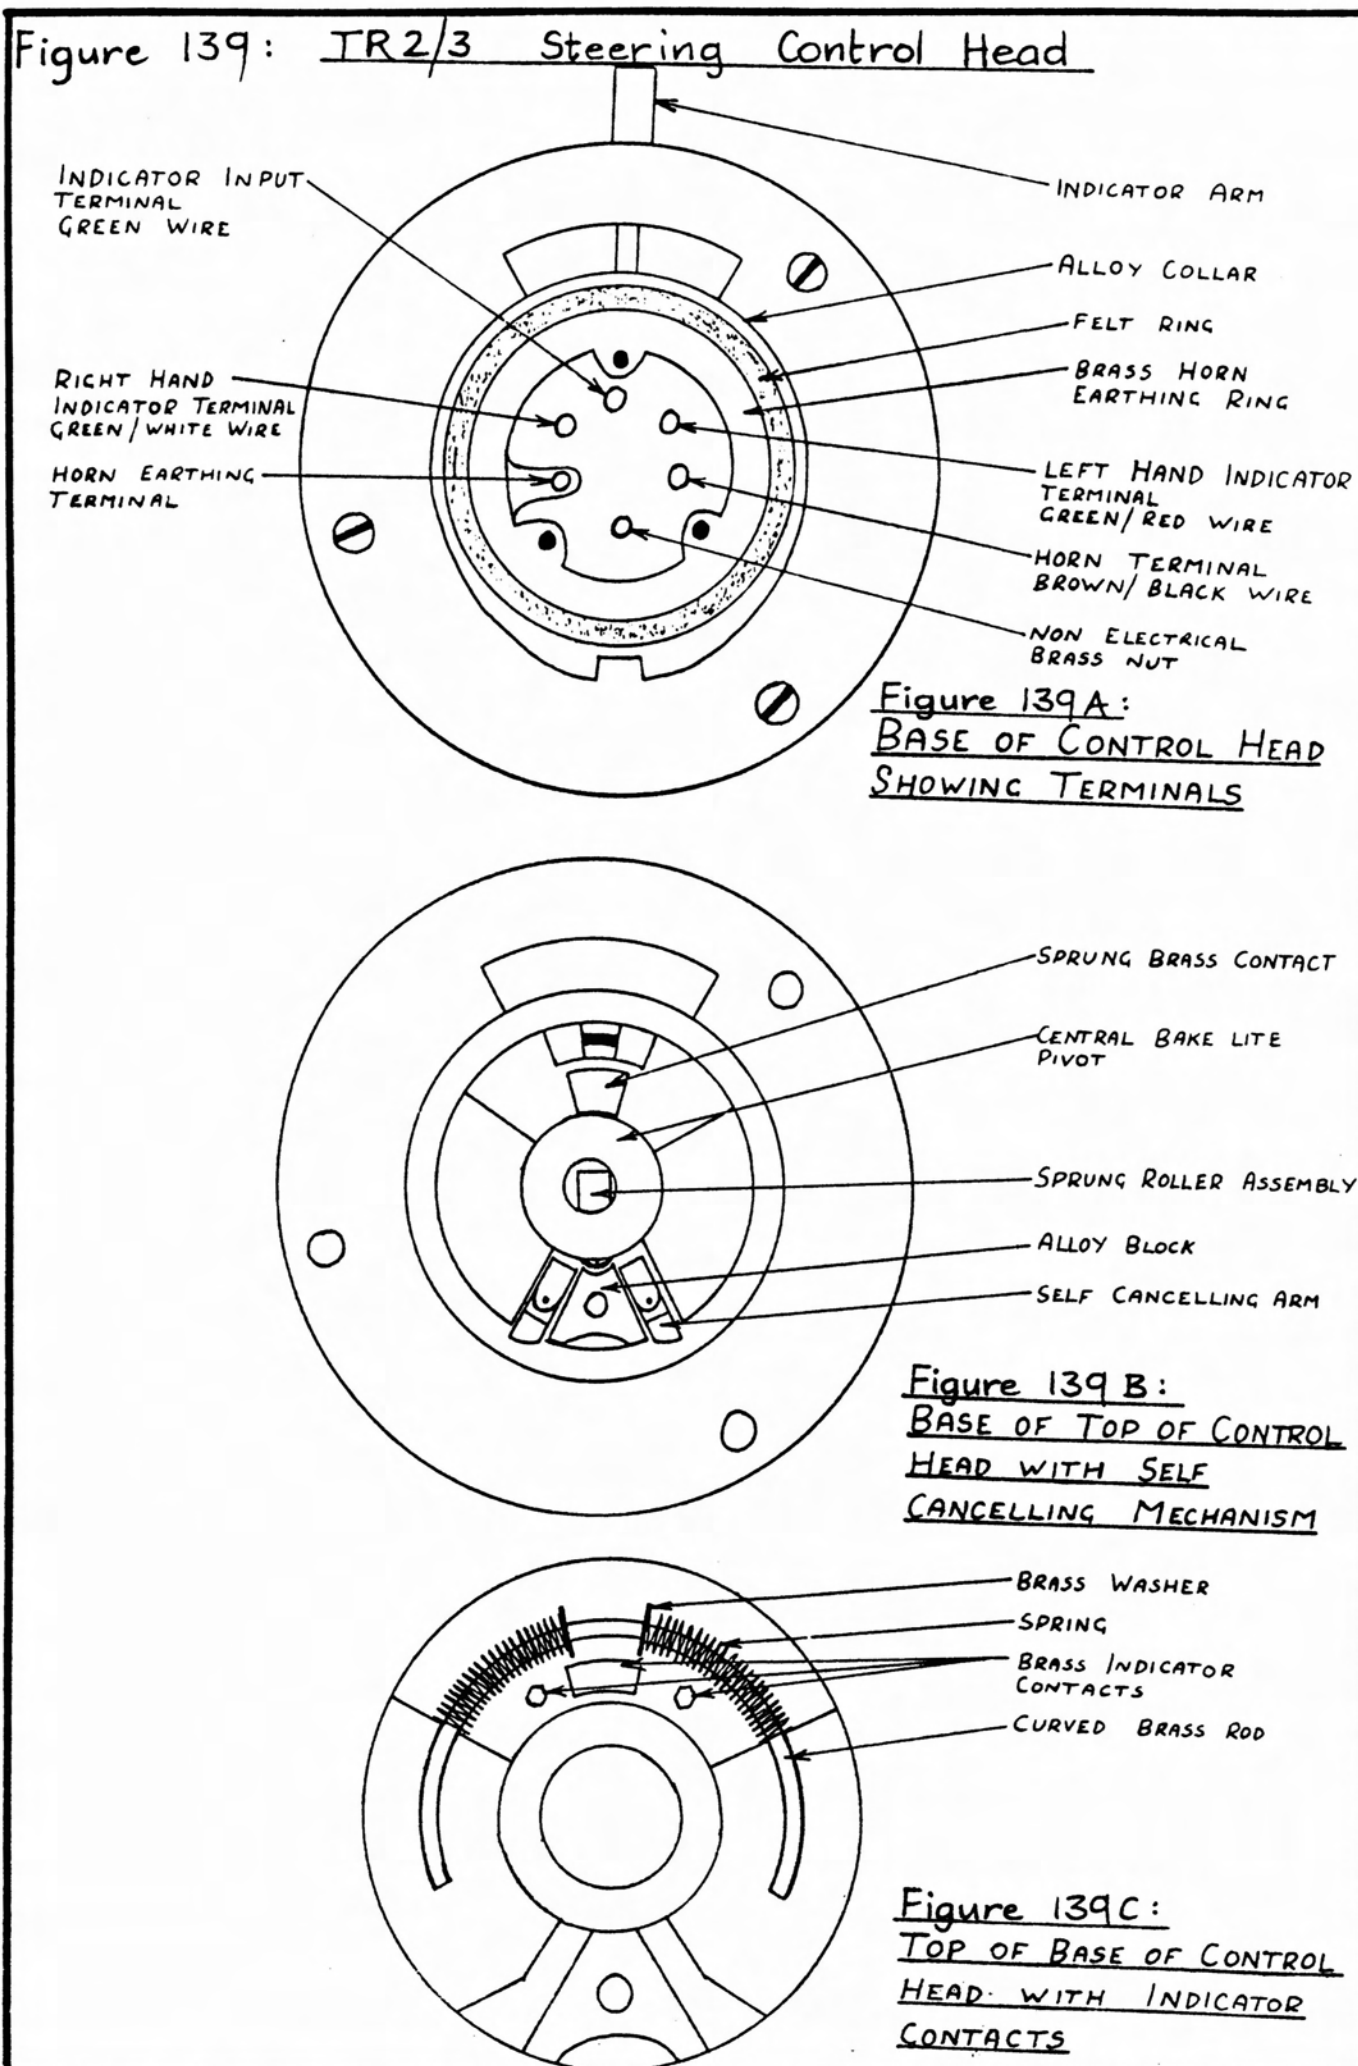
From Richard Larter, who lives in Eire/Glasgow, comes this very interesting article on a subject that is most certainly not covered in any manuals. Richard is also responsible for the very clear and detailed illustrations (Figures 139A, B and C). The workshop manual states simply that if the control head is defective it must be replaced; easier said than done today! However this item is not too difficult to overhaul providing some care is taken as the bakelite casing is fragile, especially when old.

- (b) Insert the sprung roller into the central pivot.
 - (c) Push the triangular alloy block back into place against the sprung roller.
 - (d) Fit the self-cancelling arms with the bevelled sides facing each other (see Figure 139B).

- (a) Refit the central pivot to upper casing ensuring that the brass sprung electrical contact is a loose fit so the spring can push it into engagement.

- (e) The lower part of the casing is assembled with the curved rod and springs.
 - (f) Fit the two halves of the casing together, tricky but possible. The assembly is held together with the single non-electrical screw.

- (g) Attach the indicator arm using the very short countersunk screw.
 - (h) Fit the alloy collar with the felt seal facing downwards.
 - (i) Replace the horn contacts and brass earthing ring.

- (j) Refit the top cover and horn push with the wider part of the spring facing downwards.
 - (k) Replace the bottom flange.
 - (l) Replace the stator tube by pulling the wiring through with a length of stiff wire. If the unit has been rewired, bind the wires tightly and completely without any twists and pull through before soldering on to bullet connectors.
